NAVAL POSTGRADUATE SCHOOL MONTEREY CA
A-10/GAU-8 LOW ANGLE FIRINGS VERSUS SIMULATED SOVIET TANK BATTAL--ETC(U)
AUG 80 R H STOLFI, R R MCEACHIN

A-10/GAU-8 LOW ANGLE FIRINGS VERSUS
SIMULATED SOVIET TANK BATTALION
(HONEYWELL LOT NUMBER 0L78D043-016)
(ARRAY 3)
2 FEBRUARY 1979.

AUGUST 1980

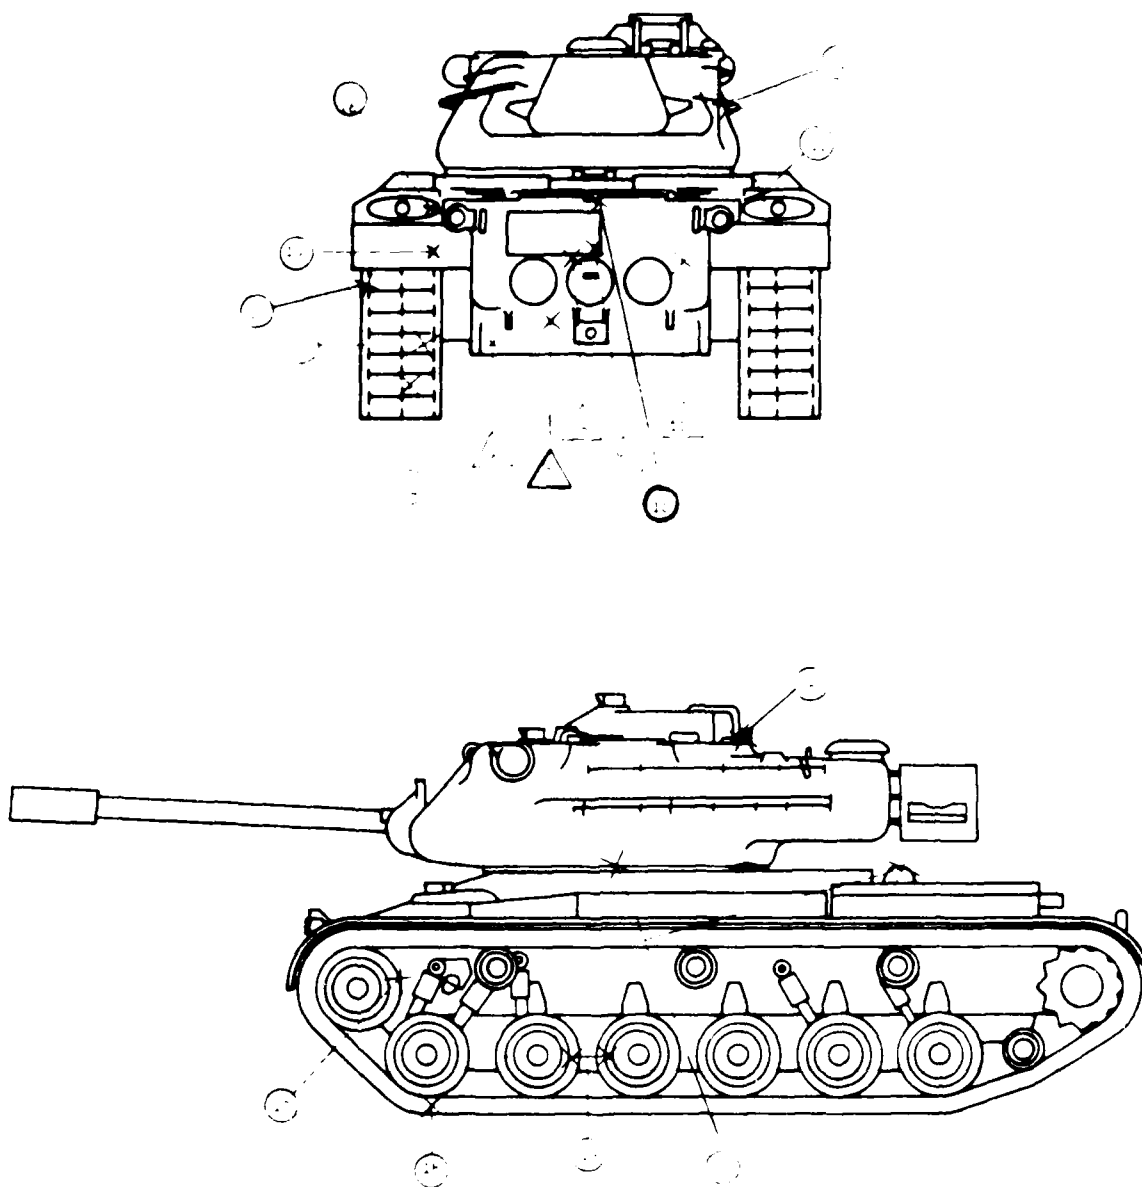
FIGURE 7. Impact Diagram, Target 2.

100% M-Kill, resulting from the following projectile impacts, shown in Figure 7:

Five of the impacts (numbers 6, 7, 8, 9, and 11) shown in Figures 8, 9, 10, 11, and 12, respectively, achieved perforations of the armored envelope. Behind-the-plate effects of Impact 6, shown in Figure 8, could not be determined because of the location of the strike. The remaining perforations could have resulted in a mobility kill through penetrations into the transmission case, or rupture of transmission oil cooler lines. Impacts 2, 3, 4, and 18 made contributions to the kill through minor damage to the track and suspension system.

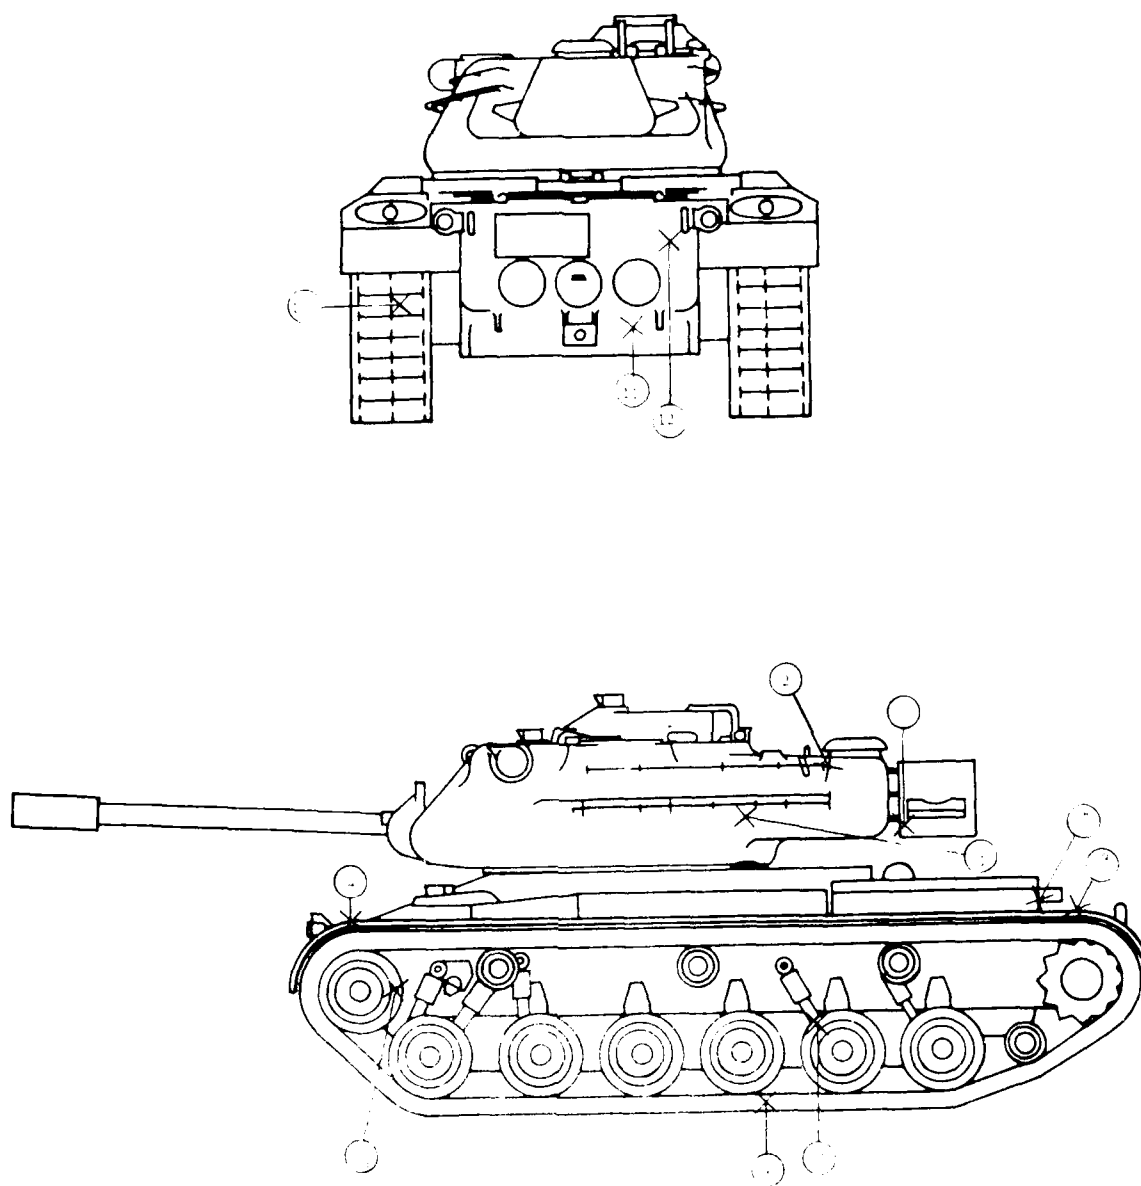
FIGURE 13. Impact Diagram, Target 4.

100% M-Kill, resulting from the following projectile impacts, shown in Figure 13:

Impact 5, shown in Figure 14, destroyed the adjusting idler hub in the left track. Two other impacts contributed to the kill through minor damage to the track.

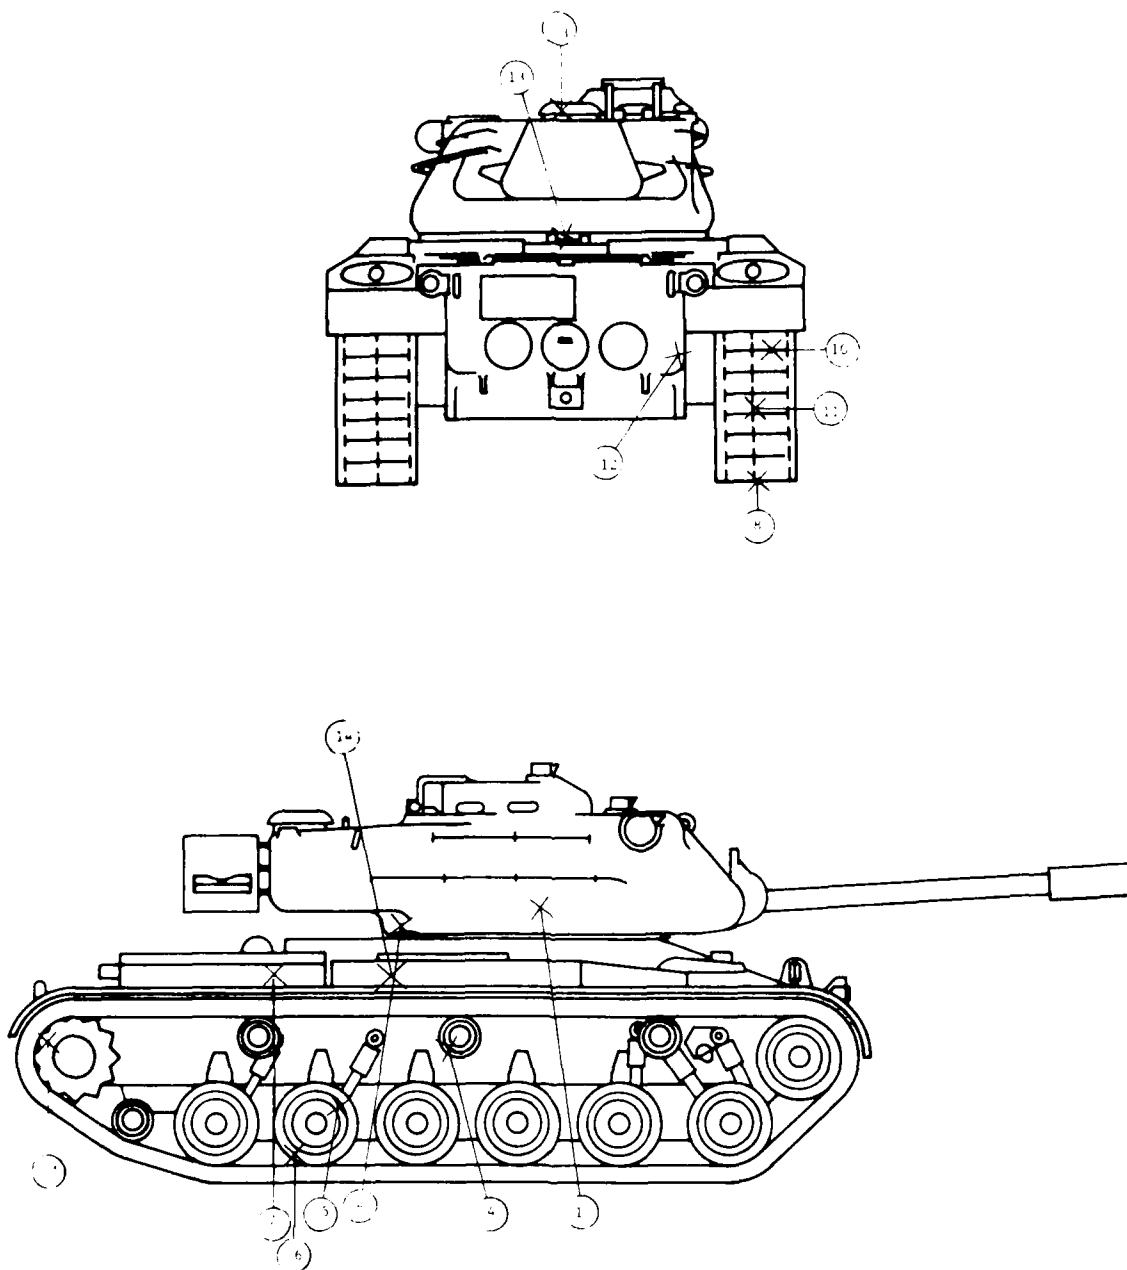
FIGURE 15. Impact Diagram, Target 7.

20% M-Kill, resulting from the following projectile impacts, shown in Figure 15:

Mobility was estimated to have been degraded by 20%, due to cumulative damage to the track and suspension system resulting from seven hits. Impact 9, shown in Figure 16, is representative of the most severe damage inflicted during this attack pass.

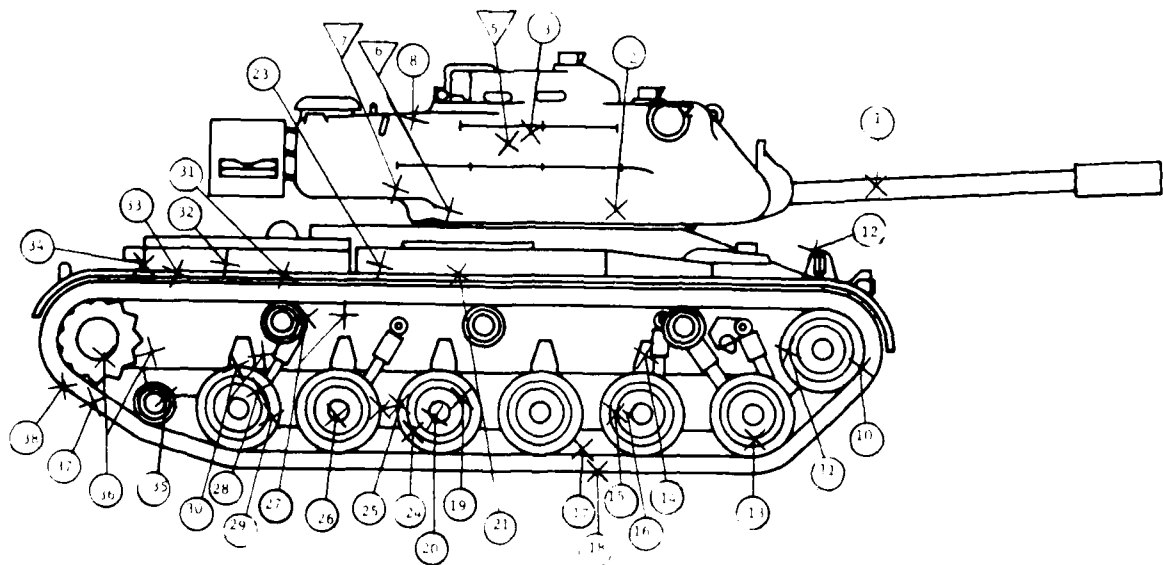
FIGURE 17. Impact Diagram, Target 17.

100% K-Kill, resulting from the following projectile impacts shown in Figure 17:

The rear hull was perforated by Impacts 41 and 42, which perforated the transmission case and severed an oil cooler line. Either of these impacts could have ignited oil in the transmission compartment.

A small fire, which could not be extinguished by the crew due to casualties, provides the best scenario for assessment of a K-Kill. The most likely place of origin of the fire is the transmission/engine compartment.

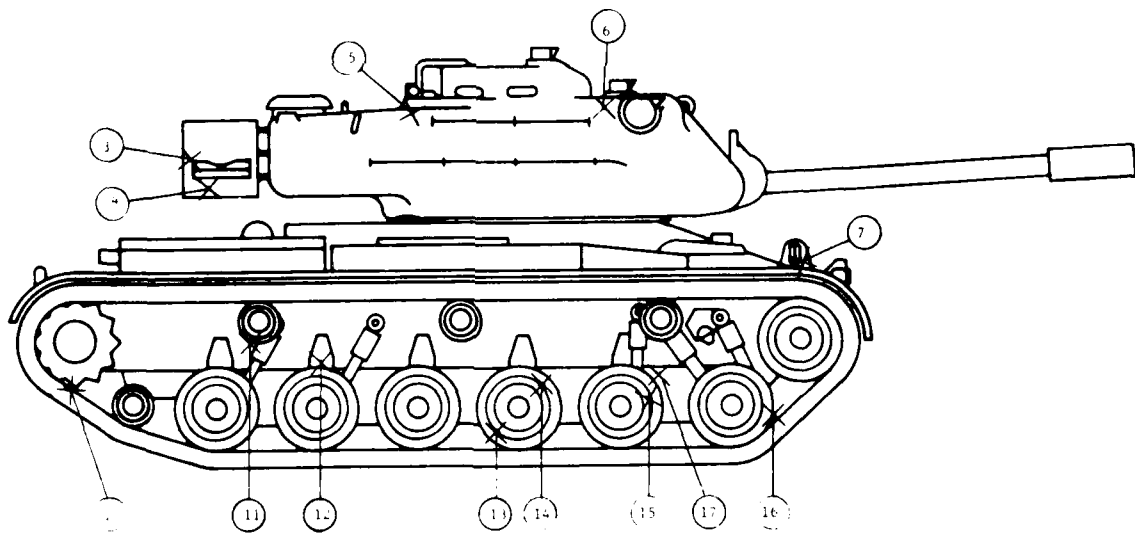
FIGURE 21. Impact Diagram, Target 19.

100% M-Kill, resulting from the following projectile impacts, shown in Figure 21:

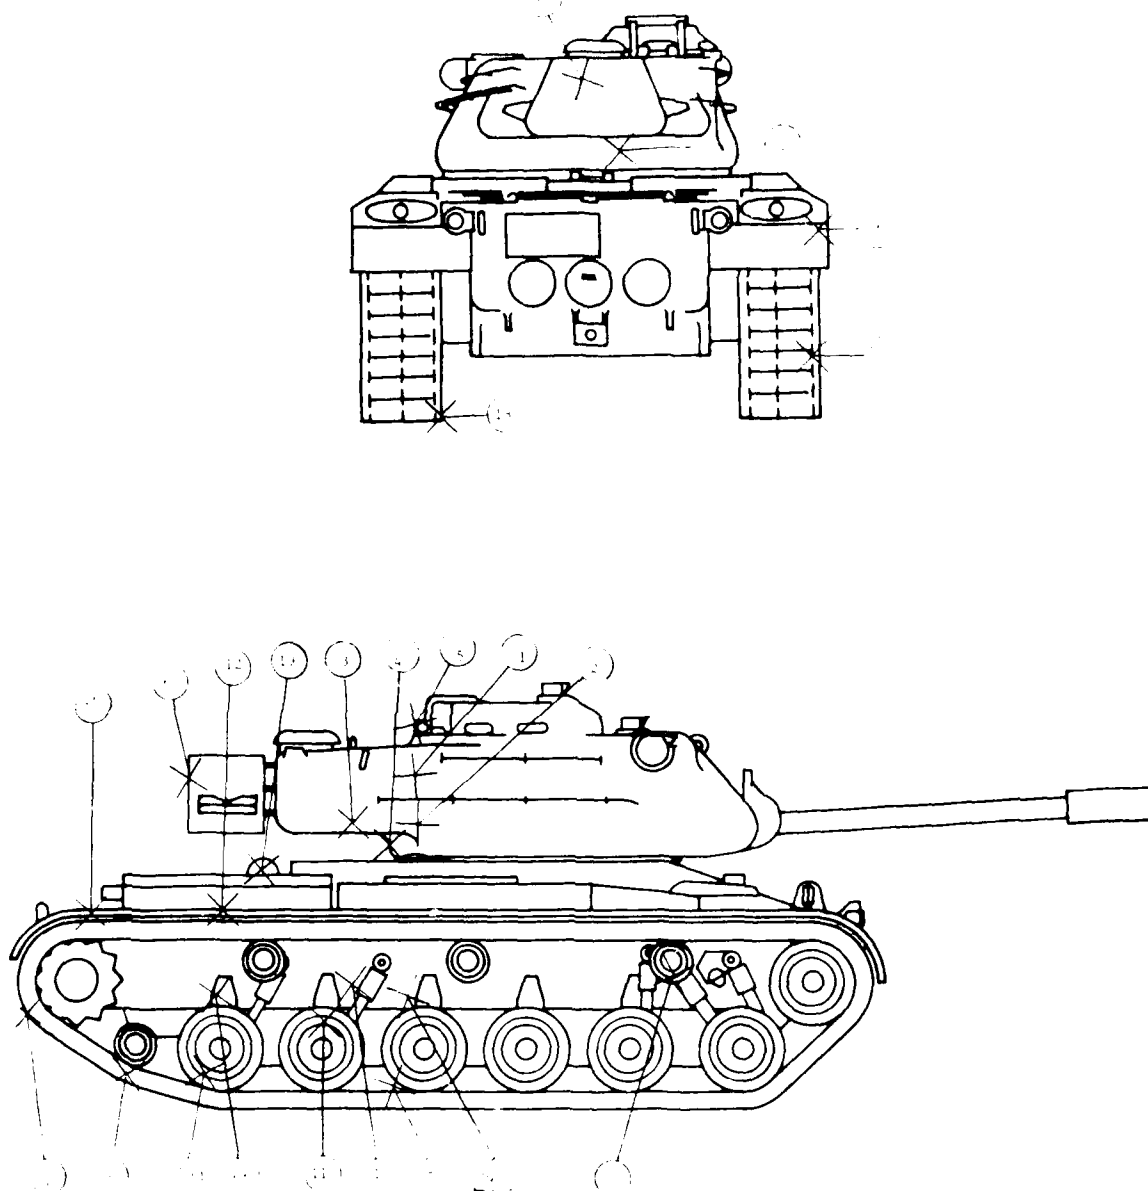
FIGURE 23. Impact Diagram, Target 20.

100% M-Kill, resulting from the following projectile impacts, shown in Figure 23:

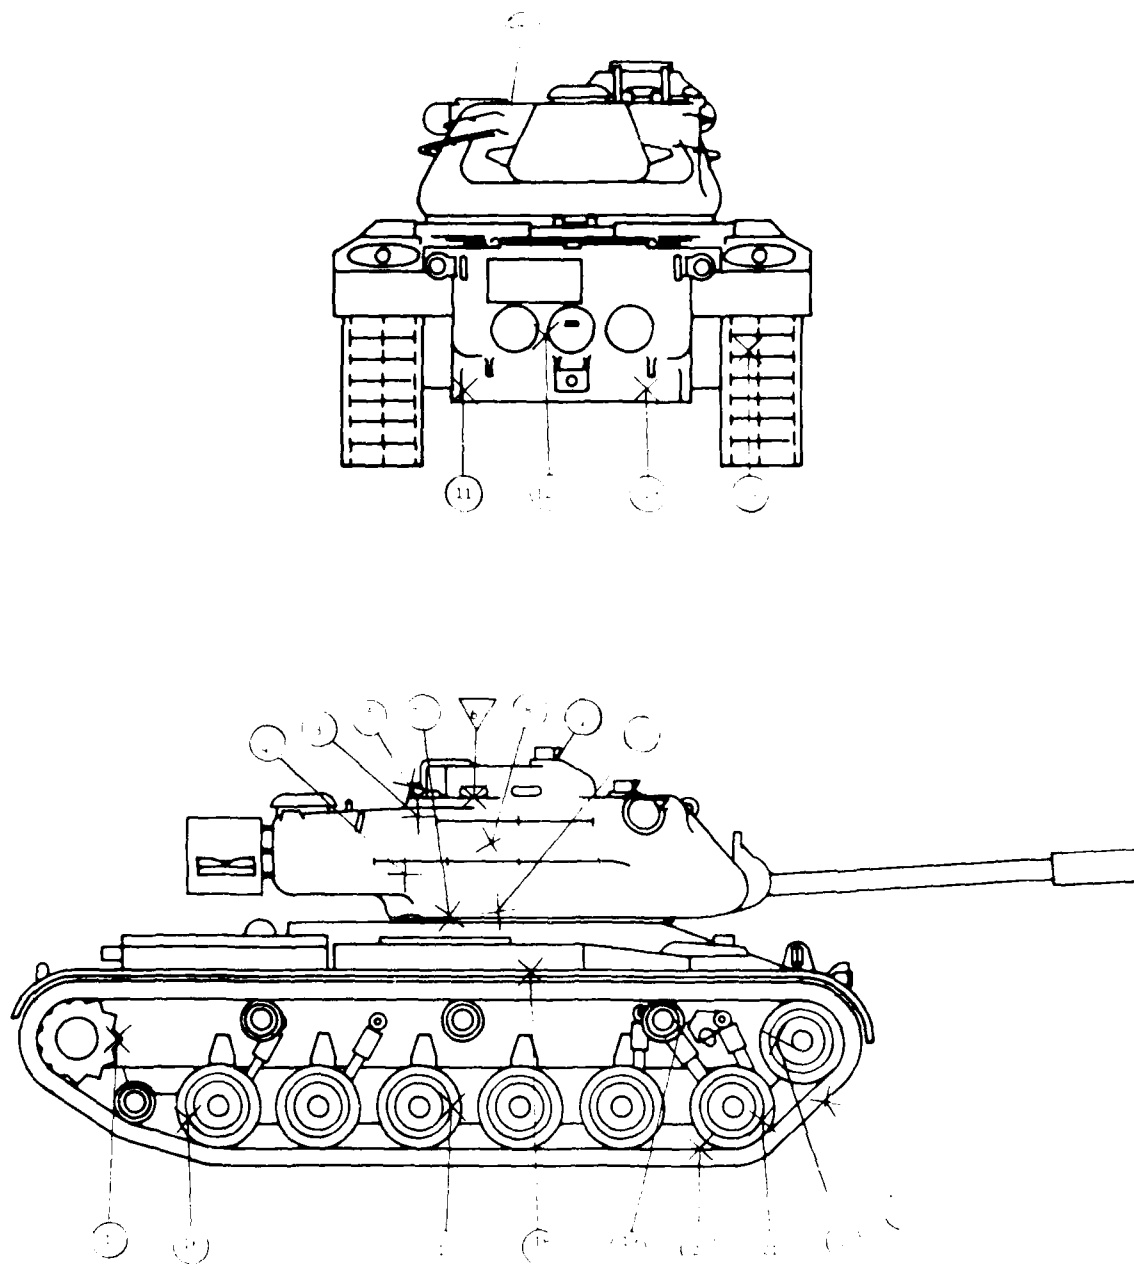
FIGURE 25. Impact Diagram, Target 21.

75% M-Kill and 100% F-Kill resulting from the following projectile impacts, shown in Figure 25:

- a. M-Kill: An overall 75% M-Kill was assessed, based primarily (65%) on crew casualties (tank commander and gunner) caused by impacts 6 and 9, shown in Figures 26 and 27, respectively, and secondarily (10%) on cumulative damage to the track and suspension system caused by three other impacts.
- b. F-Kill: 100% F-Kill was due to crew casualties from impacts 6 and 9, and to impact 7 (Figure 28) which jammed the turret, preventing it from traversing.

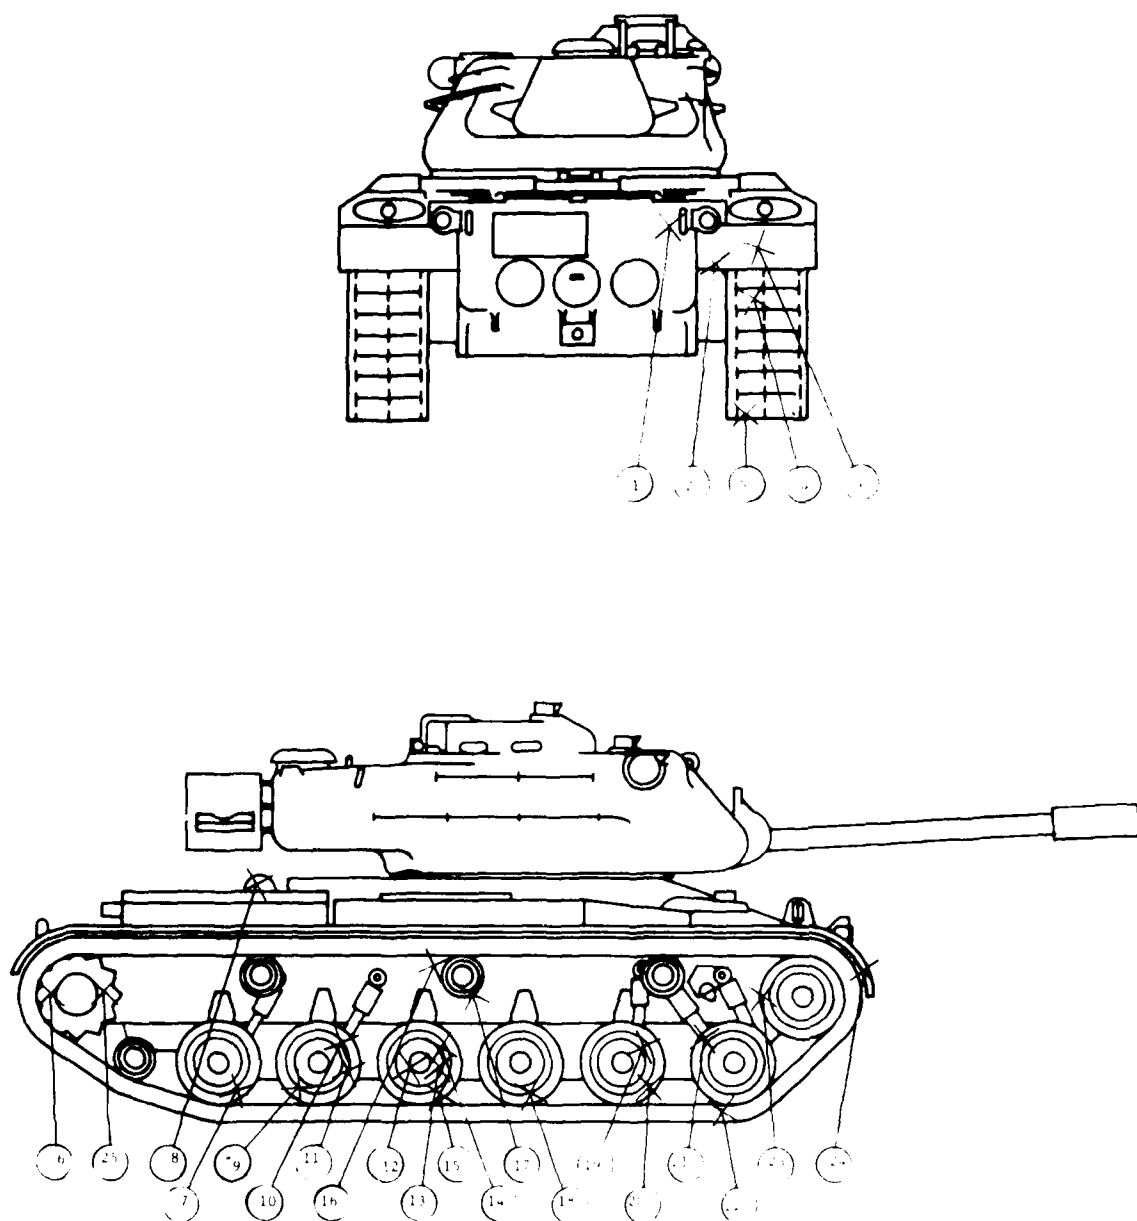
FIGURE 29. Impact Diagram, Target 22.

100% M-Kill, resulting from the following projectile impacts, shown in Figure 29:

The primary contributors to the kill were impacts 10 and 12, shown in Figures 30 and 31, respectively, which destroyed the right #4 roadwheel bearing spacer and hub, damaging the spindle; and impacts 6 and 25, shown in Figures 32 and 33, respectively, which severely damaged the right drive sprocket. Cumulative damage from four other impacts contributed to the kill.

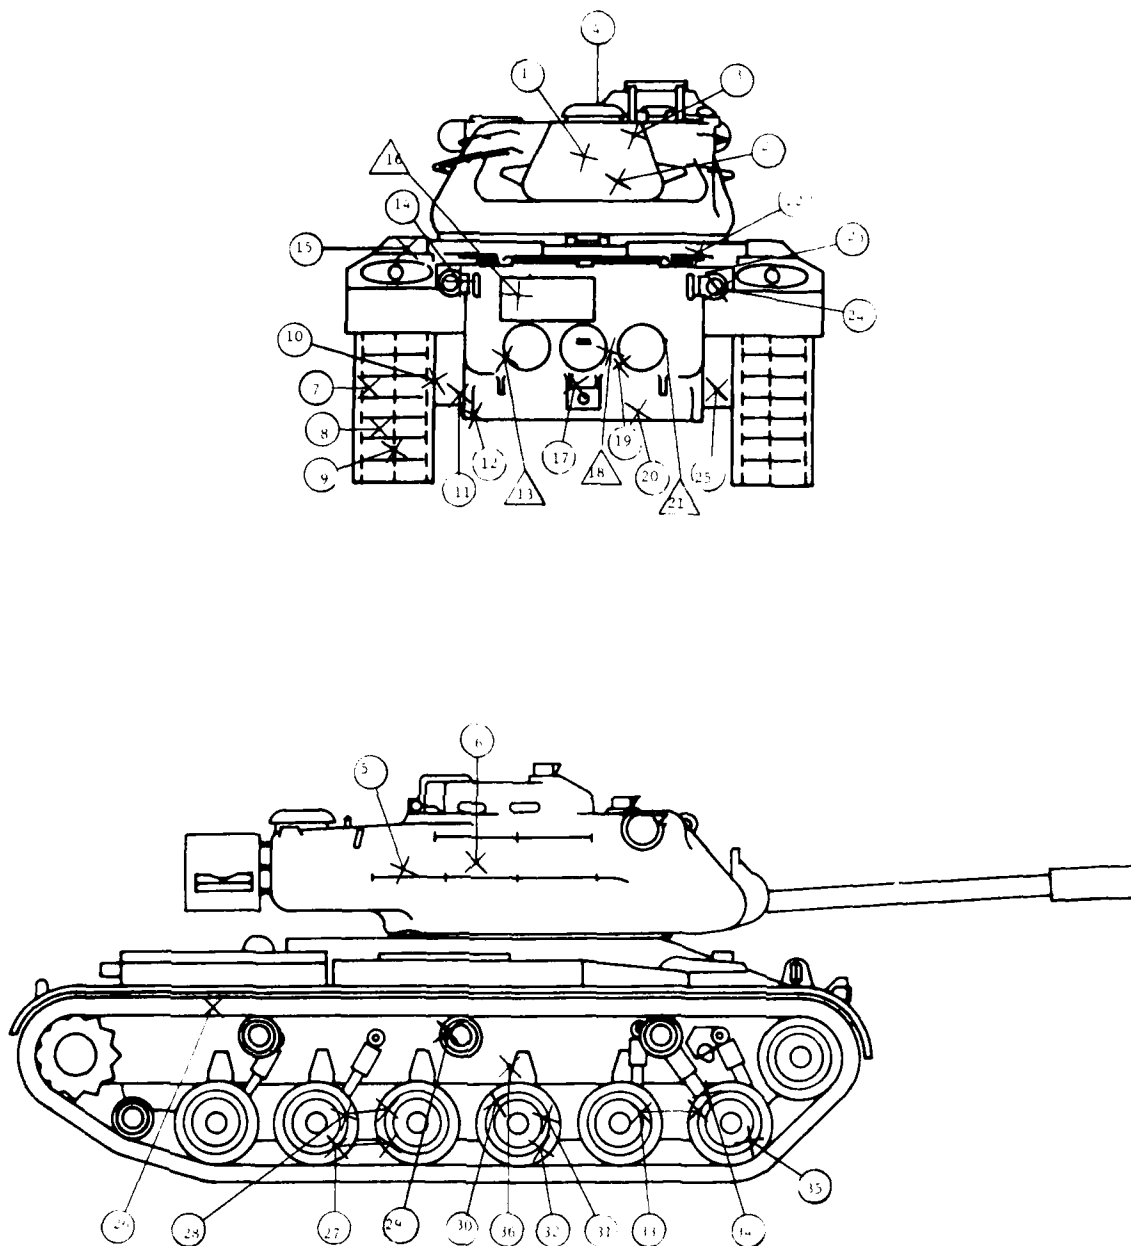
FIGURE 34. Impact Diagram, Target 23.

100% M-Kill, resulting from the following projectile impacts, shown in Figure 34:

Both final drives were damaged sufficiently to cause an M-Kill. Impacts 10 and 11, shown in Figures 38 and 39, respectively, penetrated the left final drive. Impact 25 (Figure 40) penetrated the right final drive.

Cumulative damage to the track and suspension system from 11 other impacts (numbers 7, 8, 9, 28, 29, 30, 31, 32, 34, 35, and 36 contributed to the kill).

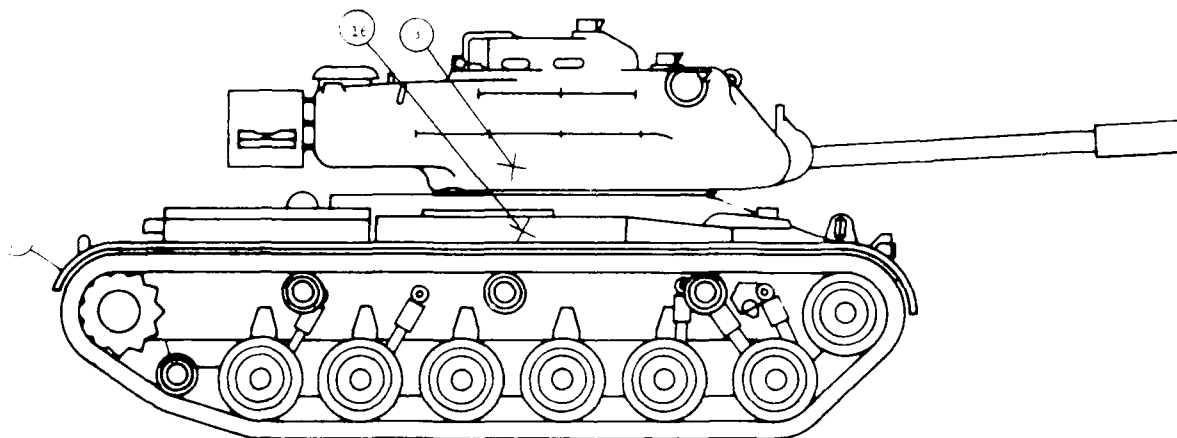
FIGURE 41. Impact Diagram, Target 26.

100% M-Kill, resulting from the following projectile impacts, shown in Figure 41:

A 100% M-Kill was assessed because of Impacts 12 and 13, shown in Figures 42 and 43, respectively, which perforated the rear hull armor and penetrated the transmission case. Two other impacts (4 and 6), which caused slight damage to the track, made a minor contribution to the kill. One other hit (Impact 9) perforated the rear hull into the transmission compartment, but the extent of the damage could not be determined.

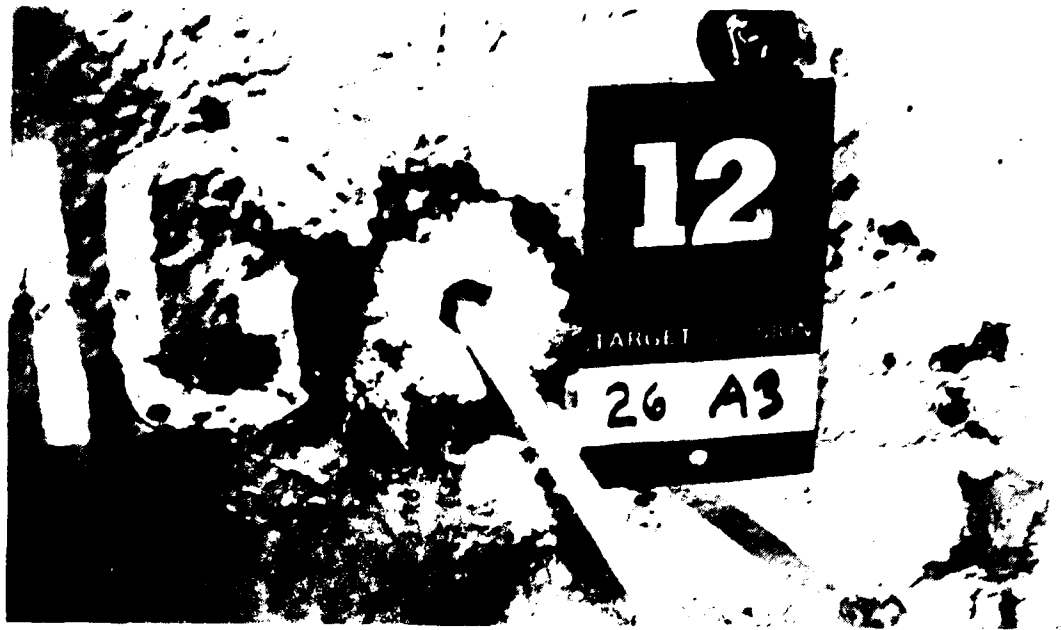
FIGURE 42. Target marker, target 26, Perforation of Rear
 axle Area and Penetration into the Transmission
 Case.

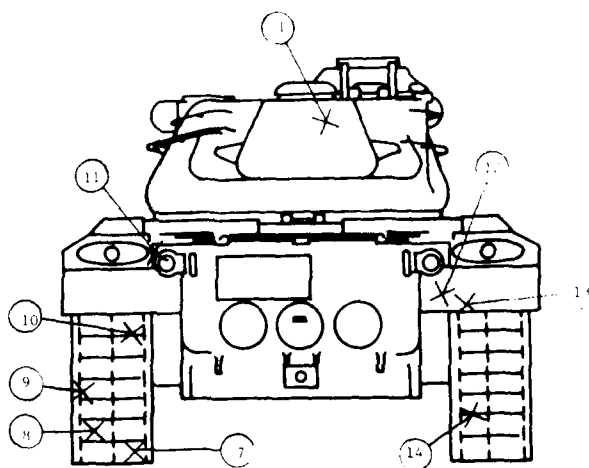
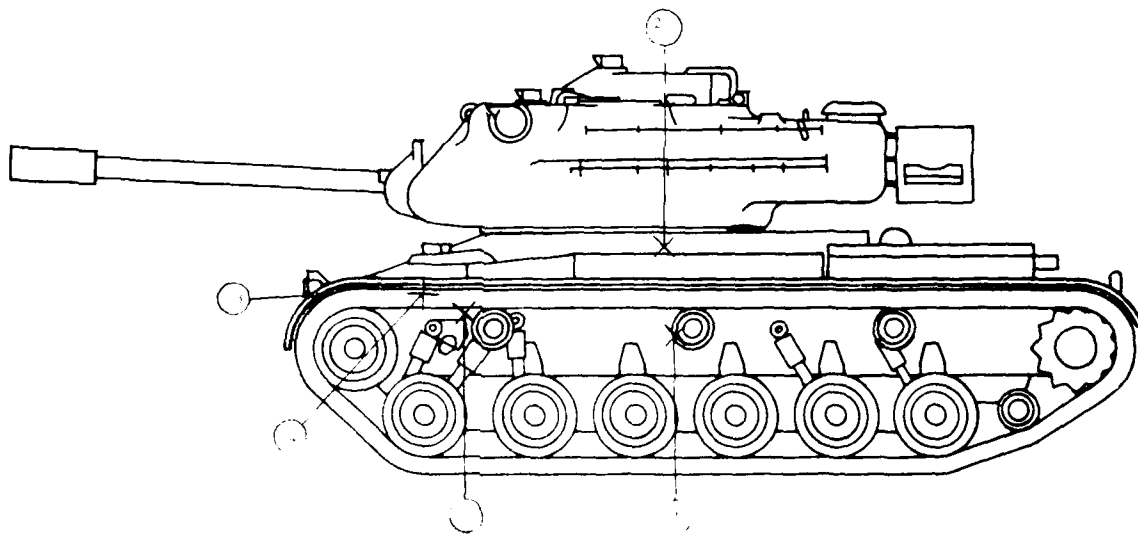
FIGURE 44. Impact Diagram, Target 27.

10% M-Kill, resulting from the following projectile impacts, shown in Figure 44:

A 10% M-Kill was assessed due to the impacts on the track and suspension system. Impact 6, shown in Figure 45, is representative of the most severe damage inflicted during this attack.

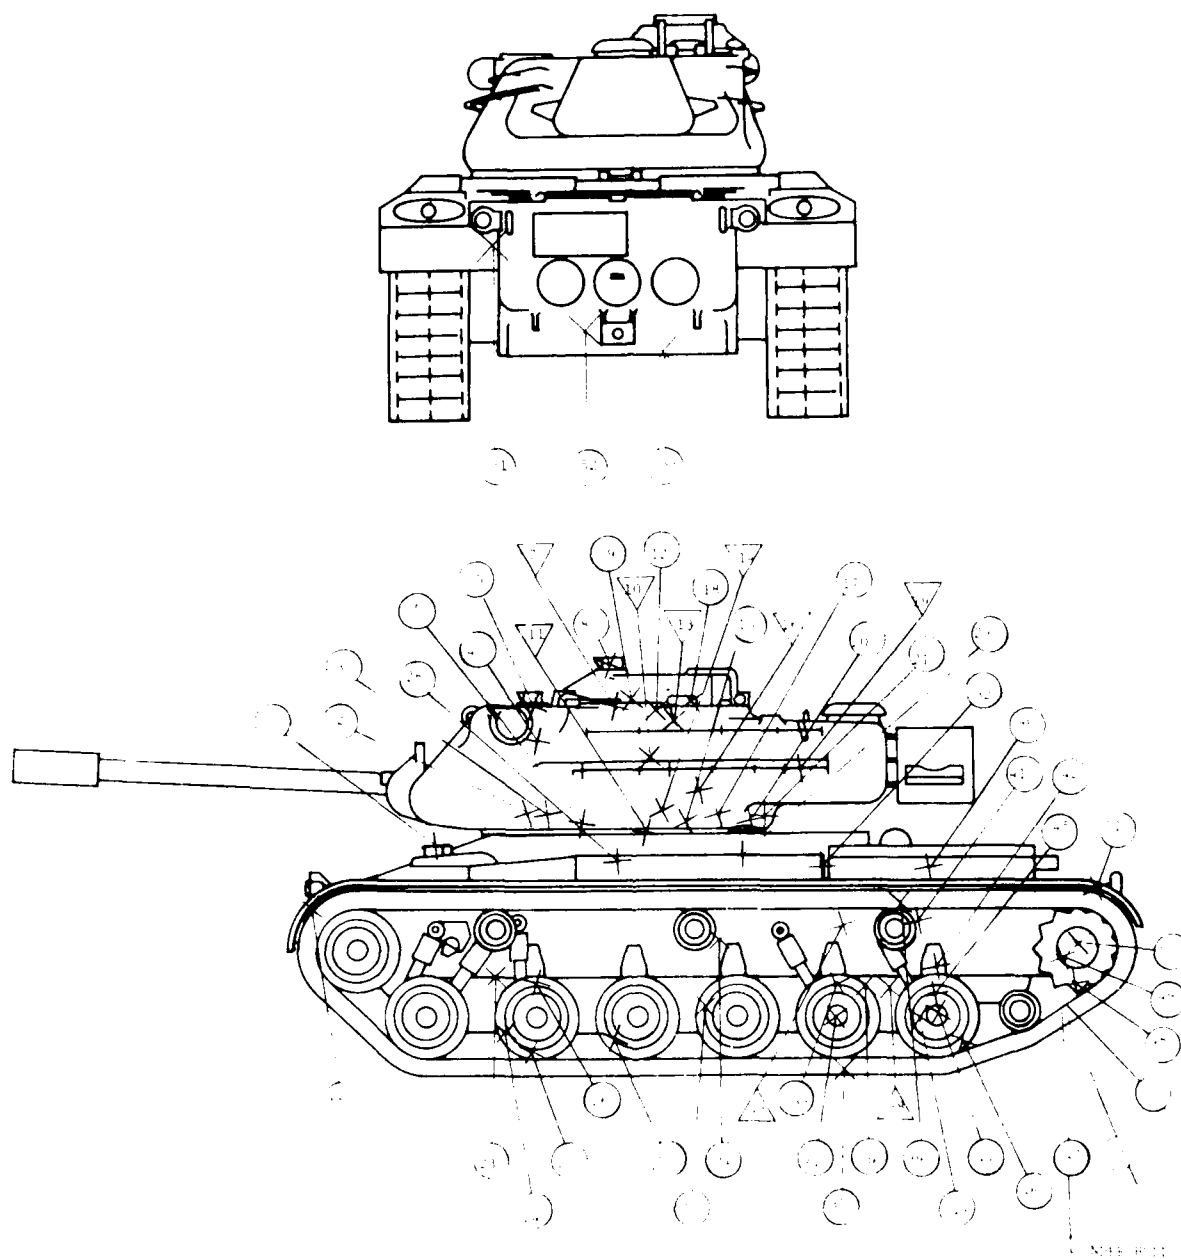
FIGURE 46. Impact Diagram, Target 28.

100% M-Kill and 95% F-Kill, resulting from the following projectile impacts, shown in Figure 46:

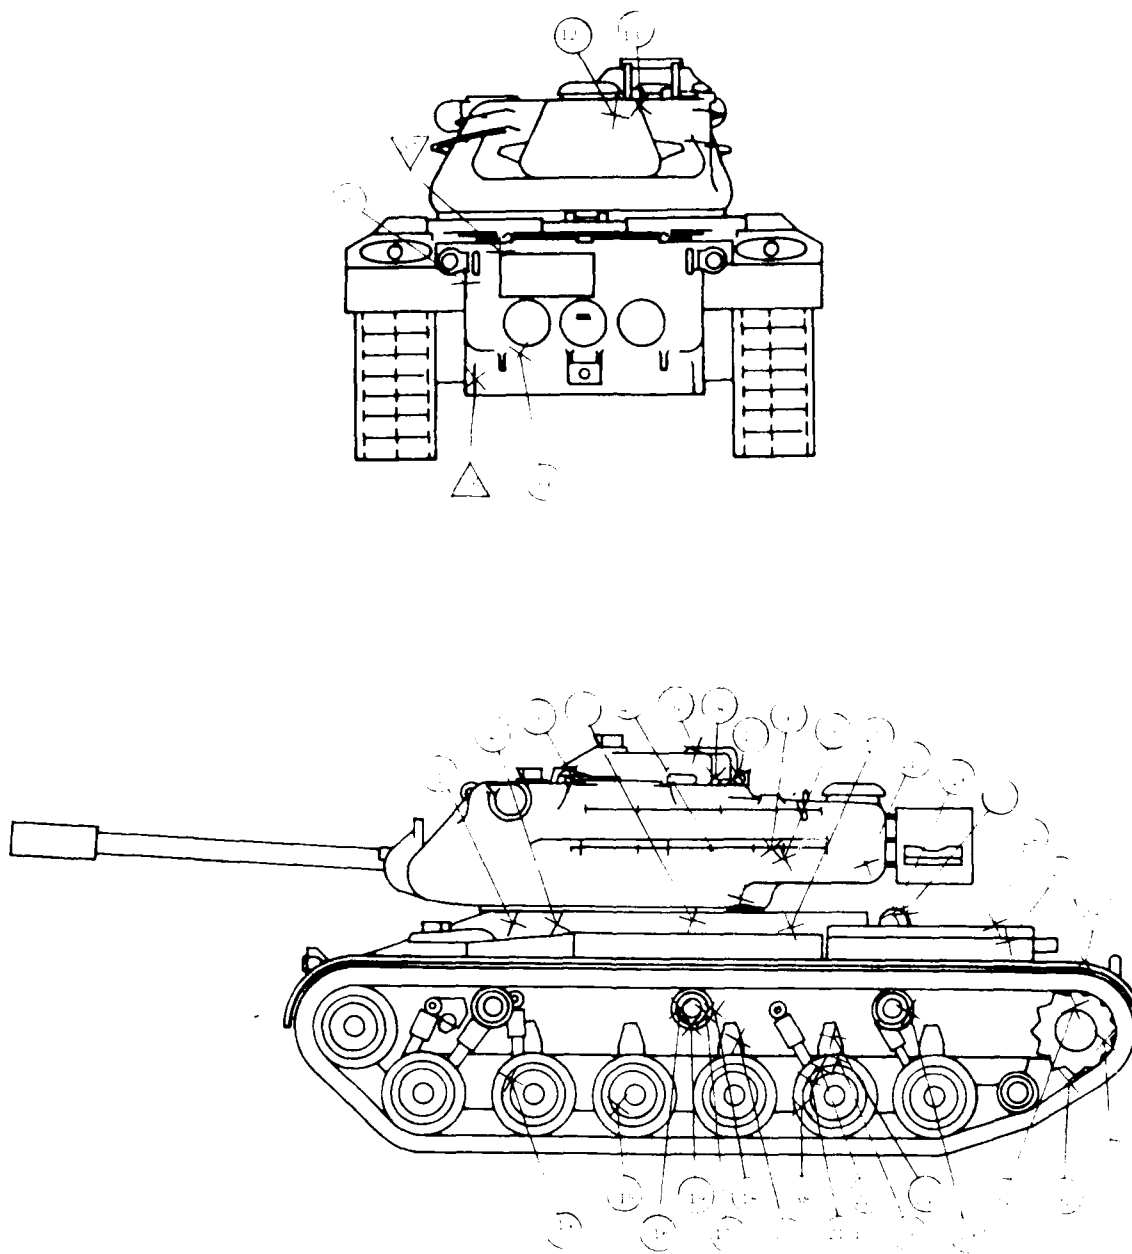
FIGURE 50. Impact Diagram, Target 29.

100% M-Kill, resulting from the following projectile impacts, shown in Figure 50:

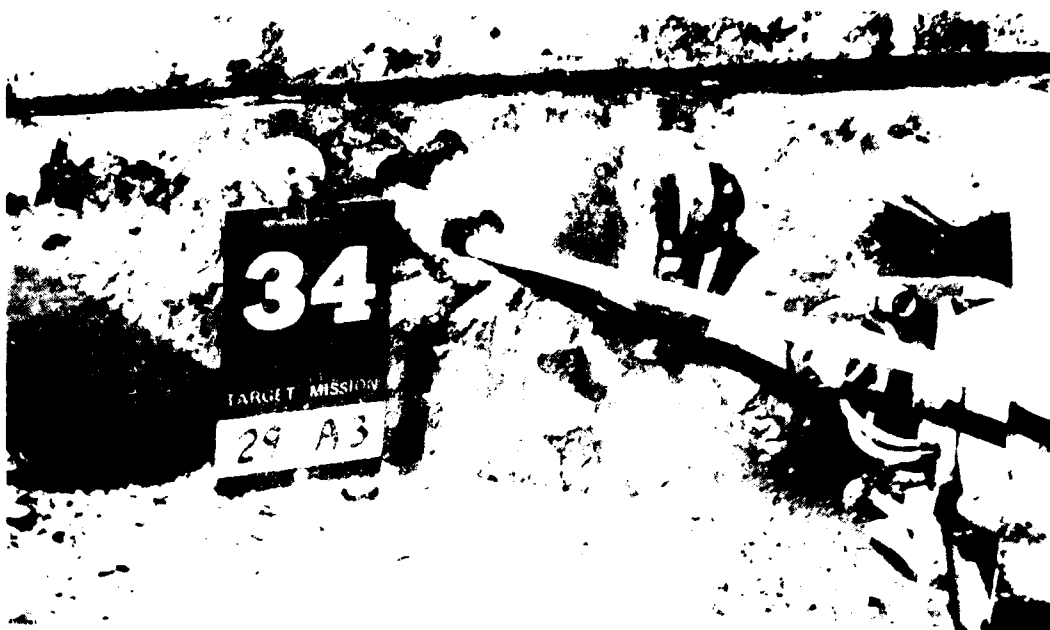
There were three perforations into the transmission compartment, one of which (Impact 37) had no behind-the-plate effects. Either of the other two perforations was capable of causing an M-Kill. Impact 34 (Figure 51) perforated the left hull armor and severed the steering control rod. Impact 36 (Figure 52) perforated the rear hull armor and penetrated the transmission case. Cumulative damage to the track and suspension system from 14 other impacts contributed to the kill.

FIG. 1. Target marker, April 27, Perforation of target which covered the steering

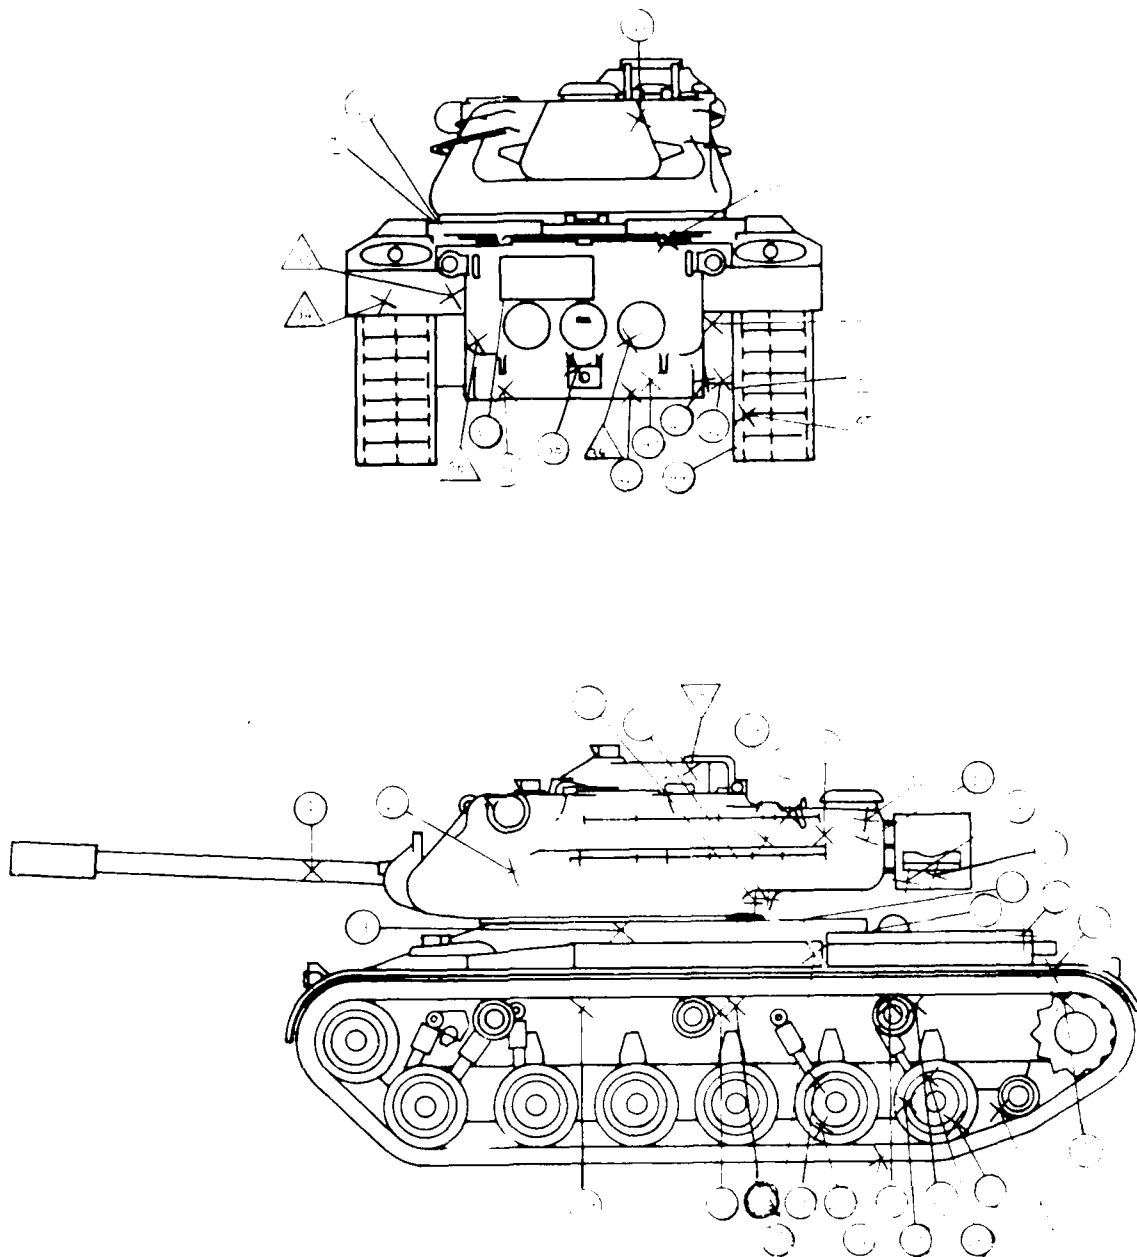
FIGURE 53. Impact Diagram, Target 30.

100% M-Kill and 100% F-Kill, resulting from the following projectile impacts, shown in Figure 53:

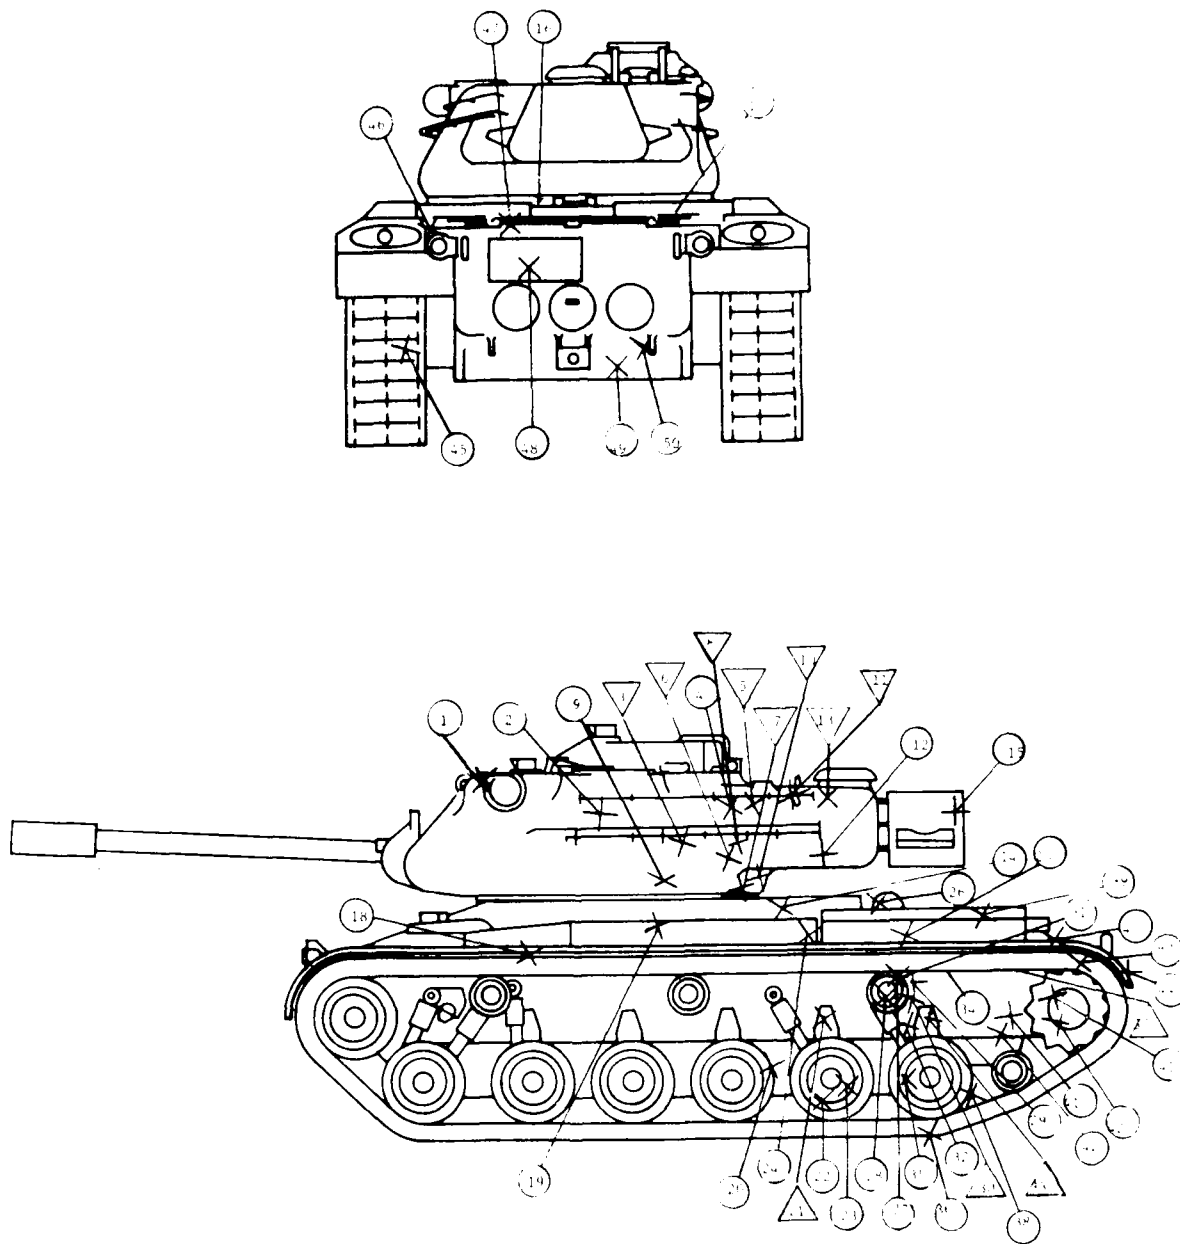
FIGURE 59. Impact Diagram, Target 31.

100% M-Kill and 100% F-Kill resulting from the following projectile impacts, shown in Figure 59:

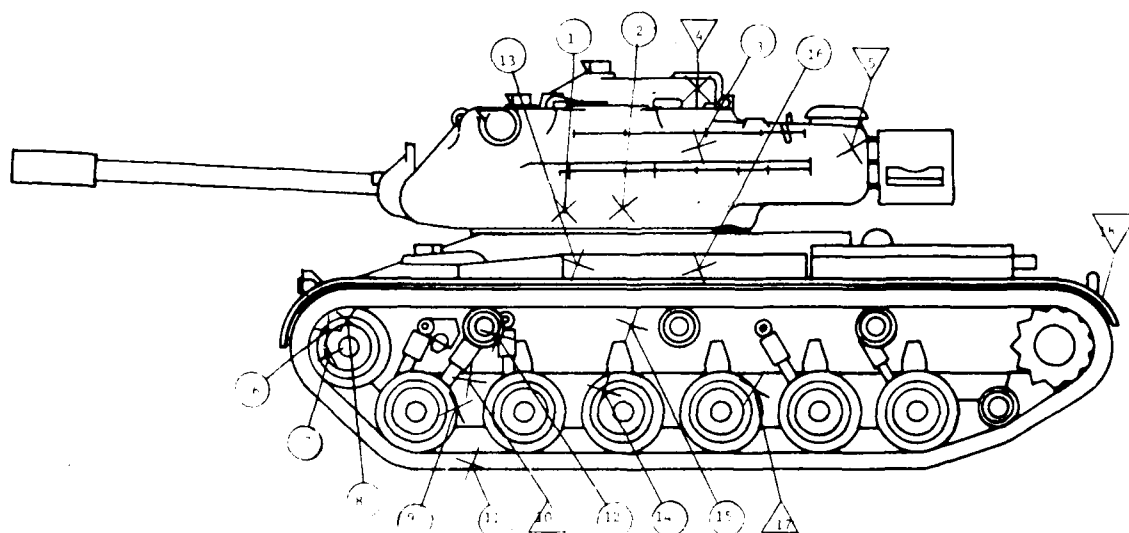
FIGURE 62. Impact Diagram, Target 32.

100% K-Kill, resulting from the following projectile impacts, shown in Figure 62:

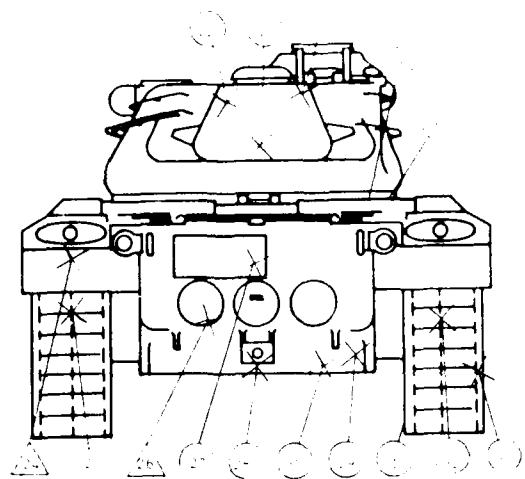
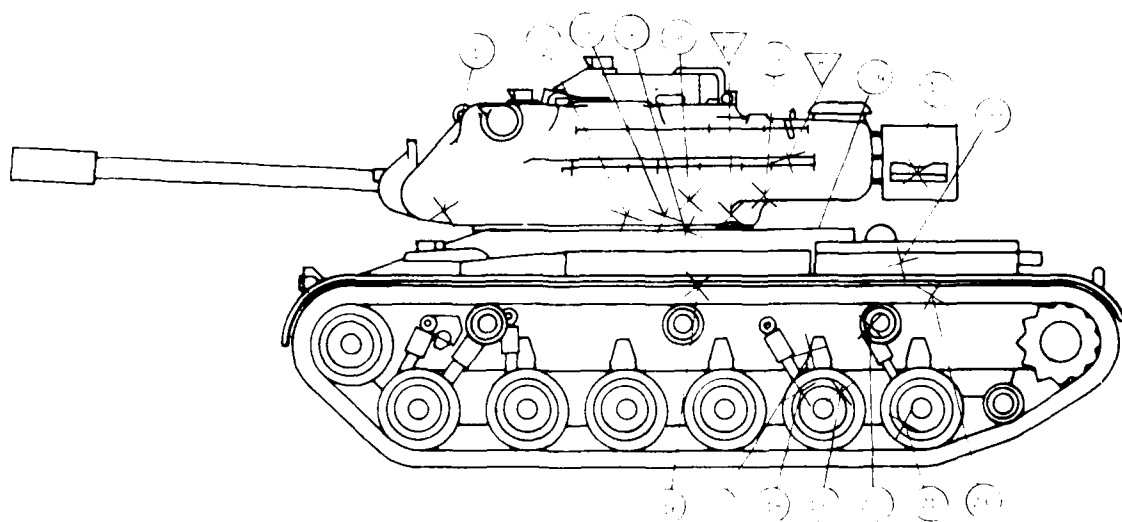
FIGURE 64. Impact Diagram, Target 33.

100% M-Kill and 95% F-Kill resulting from the following projectile impacts, shown in Figure 64:
